# **The Real Relationship Between Cracks and Vibrations: Are Cracks in Buildings Really Created by Vibrations?**

Thierry Bernard, TBT

## **Abstract**

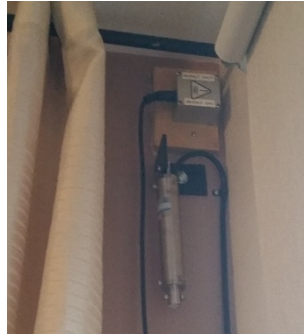
Figure 5: Tilt meter

The tilt of some building is measured via a tilt meter (Figure 5). This equipment measures the variation of the angle of the construction compared with the vertical axis. The measurement is taken every 12 hours (twice a day).

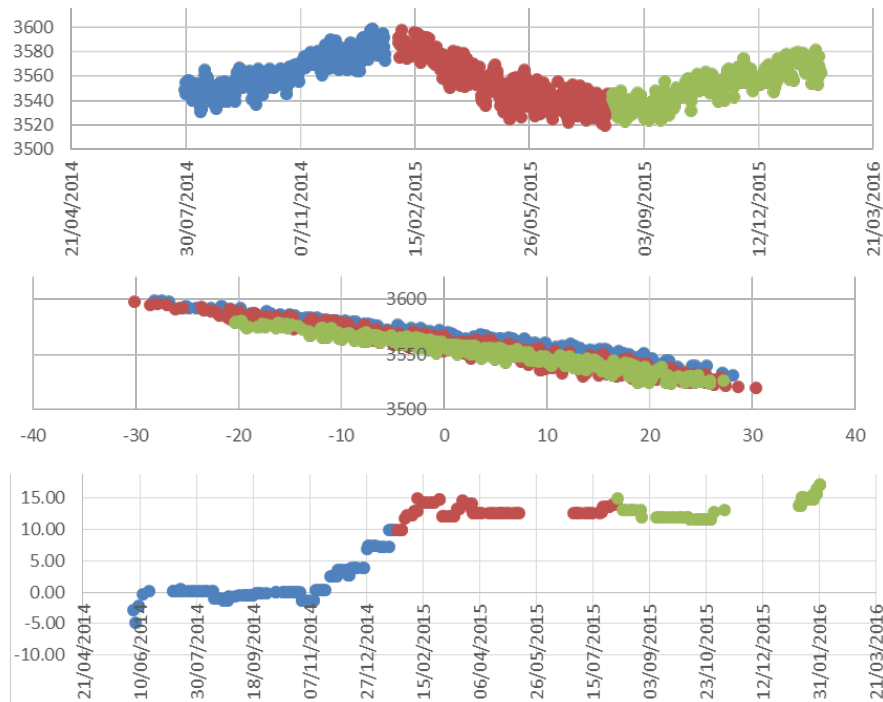
**Figure 19: Analysis example between cumulative dynamic opening and static opening**

The search for a link between the dynamic movement of the crack during a mine blast, and the static opening of the crack, that was different to the opening resulting from the temperature. The first stage consisted of analysing all the dynamic measurements and measuring the main characteristic, i.e. the deviation of the opening measured between before the mine blast and after the mine blast. The dynamic data from an extensometer were automatically analysed by specially developed software. The dynamic opening of cracks disappears after a few minutes, so the next stage consisted of comparing the cumulative evolution of the dynamic opening of the crack with the static data corrected for the effect of the temperature, in order to check if the accumulation of energy could be associated with a static evolution anomaly. In the example below (Figure 19) there are 3 graphs. The top graph represents the static opening of the crack according to time. An arbitrary colour was allocated according to the visible opening cycles (increase) or closure cycles (decrease) of the crack. The second graph illustrates the correlation between the opening of the crack with temperature, which is perfectly linear, i.e. the crack dilates and contracts solely according to the variations in temperature. The colours of the previous graph were transferred to the points according to the dates. It should be noted that there is no visible anomaly. The third graph illustrates the cumulative dynamic opening of the crack according to time.

The same colours were transferred to the graph. It should be noted that there is no correlation between the cumulative dynamic values and the perfectly linear static values.

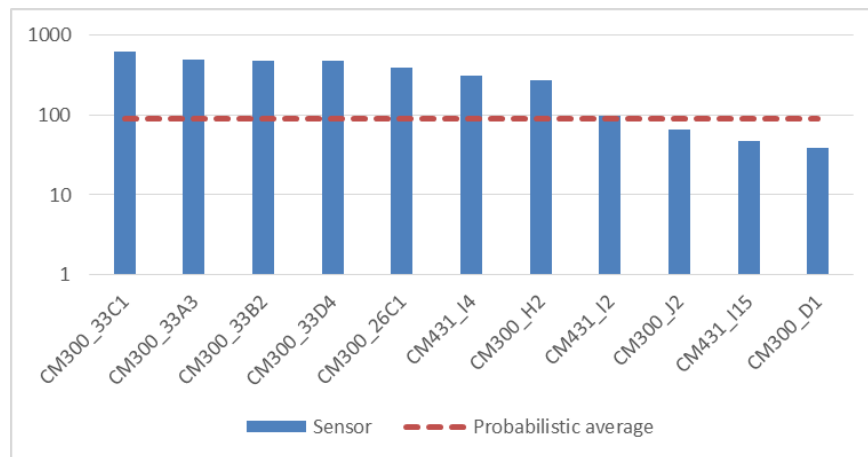
Figure 21: PPV (mm/s) susceptible to changing a 0.2 mm (0.008in) crack

being a significant visible evolution threshold of a crack. As a result, we obtain a rough probabilistic PPV of 90 mm/s (3.54 in/s), which in some cases, might make some cracks evolve by opening 0.2 millimetres (0.008 in), a value which is significant when the solicitations are repeated. This value is taken as the hypothesis of a threshold that can dynamically change the crack beyond the elastic field, permanently.

WARNING: these values have no link with the level of vibration that might create a new crack in healthy material. To do so, we would need to attain the tensile breaking point, which for concrete, whose average compressive strength is 40 Mpa (5801 psi), and which has a density of 2.4, is approximately 4 000 mm/s (157.4 in/s).
